Facilities Division Loading Dock Safety Self-Assessment

*Lawrence Berkeley National Laboratory
Janice Sexson, Heather Pinto*

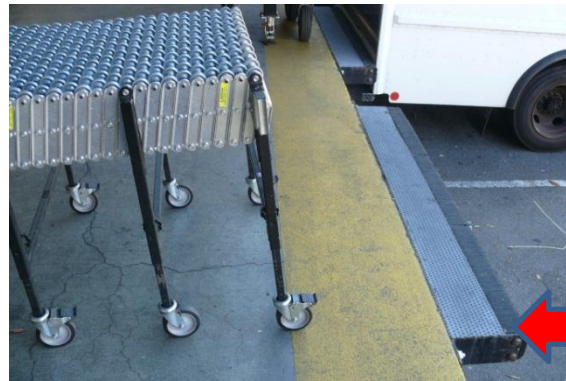
Photo 1 Dock bumper and conveyor belt

Dock Bumpers

Customers have been known to jump on and off the dock. The dock ranges in height from 32 to 43 inches. During the field observation the Self-Assessment Team witnessed a customer, although within 2 feet of the staircase, jump off the dock. There are three sets of stairs to access the dock, and customers use two of these routinely. One set of stairs is located in front of the office area and to the side of the dock. However the other two sets of stairs require walking through the truck traffic to reach the dock, and then arriving in the middle of the active dock area.

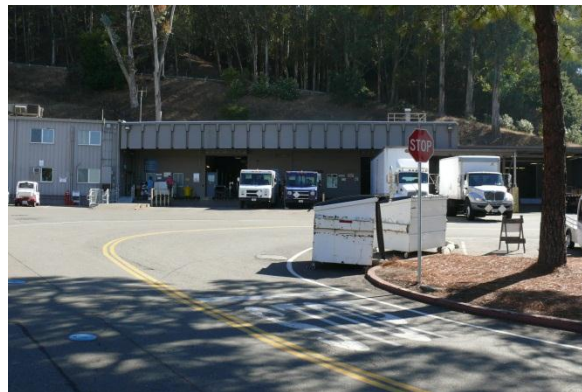
Photo 2 Building 69 Loading Dock

The Self-Assessment Team monitored dock activities during peak business hours. During this period, nine customers accessed the loading dock area. One person was seen to wander on and off the dock, with no apparent purpose, while talking on his cell phone. This person exited the middle set of stairs, between two running trucks. Attempts by the team to dissuade this behavior had no results, as the individual would not speak to the Self-Assessment Team insisting he was “on the phone” and should not be interrupted. Dock employees indicated that they too have occasionally experienced resistance from customers during attempts to redirect pedestrian traffic. Currently there is no policy preventing access to the dock by non-shipping/receiving employees.

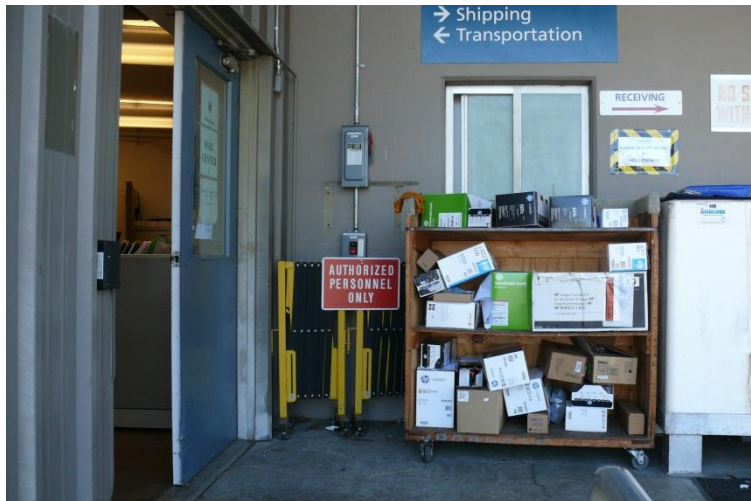
Photo 4 Out of use barricade

Employees were asked why the barricade was no longer in use. The majority recall that the barricade was only in use for a short time, if ever. One employee remembers the barricade being an obstacle to the Transportation/Receiving office employees as they walked back and forth to the Shipping and Receiving area. When the barricade was moved it was seldom put back in place.

- The barricade was cumbersome to use.
- The office design logically funneled customers to the Transportation Administrative Assistant's desk. During the self-assessment interview, the Transportation Administrative Assistant expressed frustration regarding handling customers in the office, specifically customers who were there for Shipping or Receiving needs.
- The Receiving Administrative Assistant was relocated to the Receiving area which left only one administrative person available to receive incoming customers in the office. This frequently left the office unstaffed.
- The Transportation Administrative Assistant arranged for the signage to be altered, redirecting customers across the dock for Shipping and Receiving service.

- Develop a policy restricting dock access to LBNL Material Handlers, Vendor Delivery Drivers, and Shipping/Receiving/Transportation employees.
- Design a customer process for Shipping/Receiving that prohibits dock access:
 - Include barriers to prevent customers from accessing the dock area without escort.
 - Place chains/barricade at stair and dock entrances preventing customer access.
 - Include signage informing customers that access is restricted.
 - Set up a customer service triage area by use of either a bell/phone system to alert staff, rescheduling staff to ensure service desk coverage, or develop an alternate path of travel skirting the dock area.
 - Modify signage to reflect changes.

- Require loading dock staff replace barriers after each use.
- Evaluate replacing the existing 19 year old forklift with a forklift more suitable for the loading dock size:
 - Considerations should include maneuverability
 - Safe Handling options
 - Lifting capacity
- Replace the door seal on the dry ice locker.
- Develop a process for customers arriving to pick up dry ice who do not have PPE:
 - Either restricting use or providing PPE
- Ensure that employees who use the forklift know the lifting capacity of the forklift and the weight of the object they are attempting to lift prior to the lift.

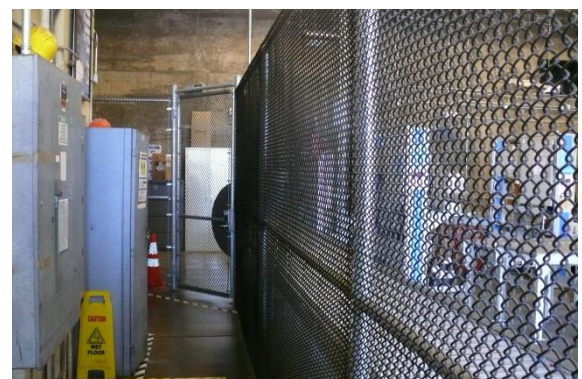
Photo 6 Shipping/Receiving Security Gate

The self-assessment results coupled with a recent event where a customer fell off the dock while chatting with dock employees, indicate that customer access to the loading dock should be prohibited (with exceptions for trained material handlers from other divisions and vendor delivery drivers). The dock can at times be a hub of activity with deliveries, forklift traffic, and materials in motion. The number of customers to the Shipping/Receiving areas could easily be managed away from the often bustling dock area. Customers should be triaged in the office and either met in the office by Shipping/Receiving staff, or routed through the security gate near the restrooms, along the back wall, away

from the dock and Receiving activities (see Appendix A). Physical barriers that are easy to maneuver but are clearly restrictive should be installed on both back sets of stairs and at the entrance to the active section of the dock (Appendix A).

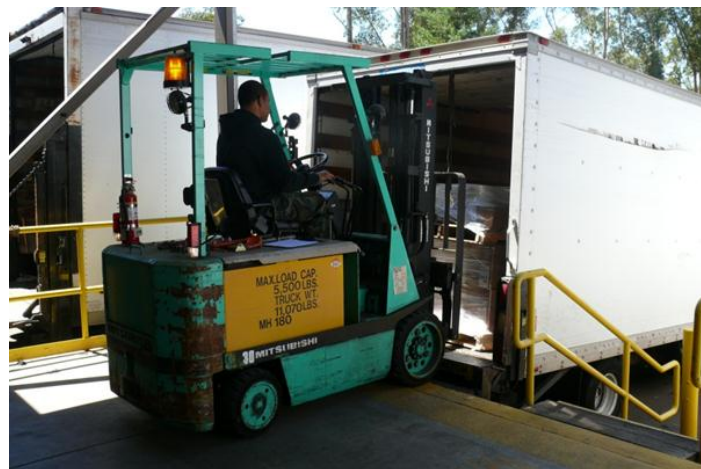
Photo 7 1994 Mitsubishi Forklift

When asked what employees thought would cause the next accident many employees brought up forklift safety due to the dock size. The width of the dock is 14 feet. Turning the forklift involves maneuvering the vehicle back and forth a number of times (similar to a 3-point-turn). One employee who regularly uses the forklift stated that sometimes he notices that “*man* I get really close to the edge” and suggested that a standing forklift with a tighter turning radius would be a safer option for the small dock. When asked about this option some were concerned that the handling of a standing forklift was very different and could create a new set of hazards. One of the concerns about having a standing forklift was the lifting capacity. It was stated that dock personnel could not function as well using a forklift with any lower lifting capacity. There is a process for handling heavier loads off the dock using a larger forklift located nearby.

Not one of the employees knew the exact lifting capacity of the current forklift. The lift capacity is clearly written on the side of the forklift in large letters, and employees know where to find it. However, the employees had to guess and most were off by at least a thousand pounds. This may indicate that lifting calculations are performed by guesstimating and load testing rather than by reading the bill of lading.

The current forklift in use is a 1994 Mitsubishi. The Facilities Division should evaluate whether a forklift more suitable for the loading dock size should be purchased. This consideration should include maneuverability, safe handling options, and lifting capacity. Standing forklifts have the capacity of lifting 4,000 pounds. Larger loads could be handled using the large forklift on the ground, which is established procedure.

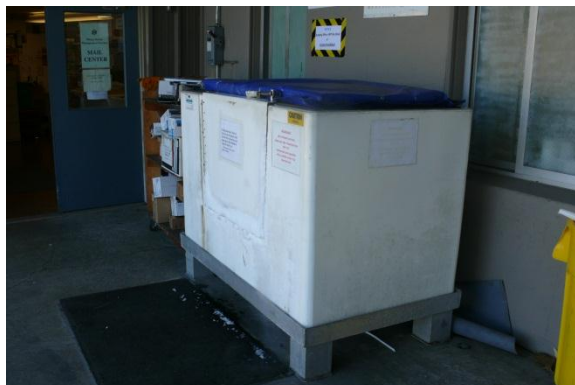
Photo 8 Dry Ice Locker

- The dry ice locker has a worn door seal which allows a buildup of ice around the door that drips water onto the dock below. A mat has been placed under the leak but does not always fully contain the water/ice. The door seal should be repaired.
- Customers coming to pick up dry ice do not always have proper PPE, specifically gloves. Permanent PPE should be made available at the dry ice locker in a clearly identified location.

- The door seal on the dry ice locker is missing, creating a slip hazard.
- Customers arrive to pick up dry ice without proper PPE putting them at risk for injury.
- Employees using the forklift were unable to quote the lifting capacity of the forklift.

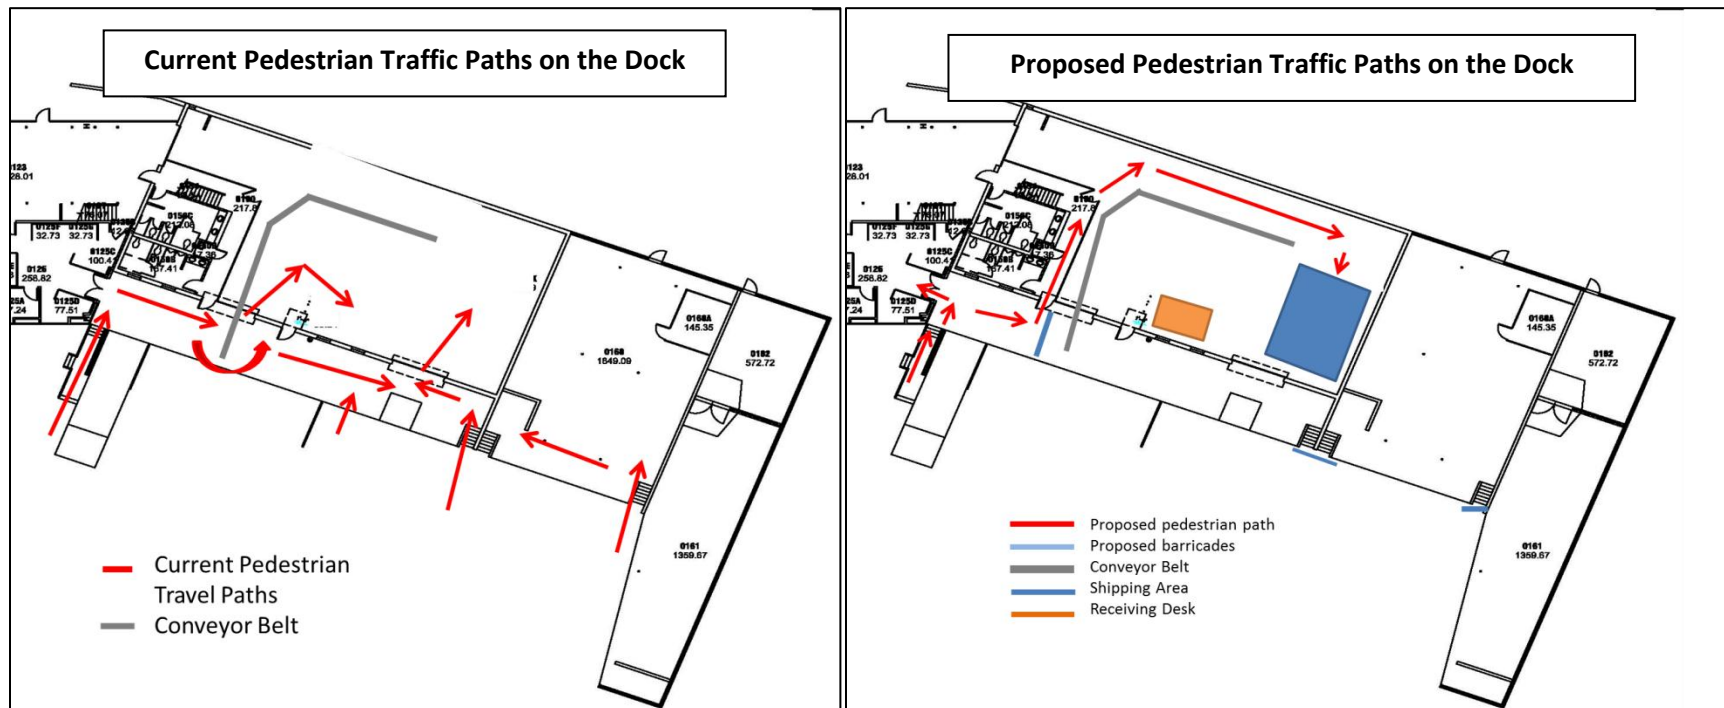
Appendix A

Current and proposed dock pedestrian traffic “maps.”
